FMG Ref: 273632 - S44580

15 October 2021

**Re: Inspection of land at 42 James Street, NORTHCOTE, VIC 3070**

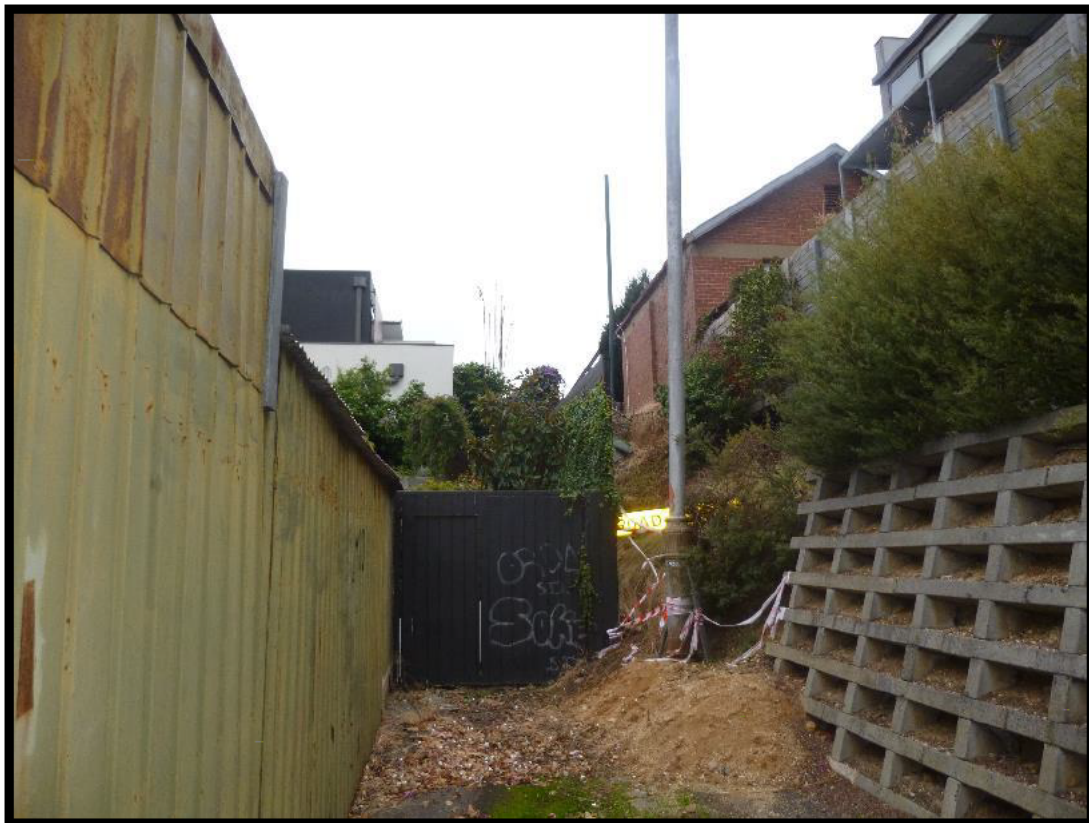
- Significant vegetation growth has occurred between November 2020 and October 2021, hence it was difficult to compare all areas of the subject land.
- It is unclear as to whether erosion of the steep slope to the eastern end of the subject land, directly adjacent to the existing concrete crib retaining wall has occurred between November 2020 and October 2021 [5 – 6]. However localised erosion of the land has occurred since April 2019 [2 – 6].

Photograph 2 – Photograph captured 29 April 2019. View of eastern end of subject land, looking west. Note spoil / loose material in laneway at the bottom of the batter.

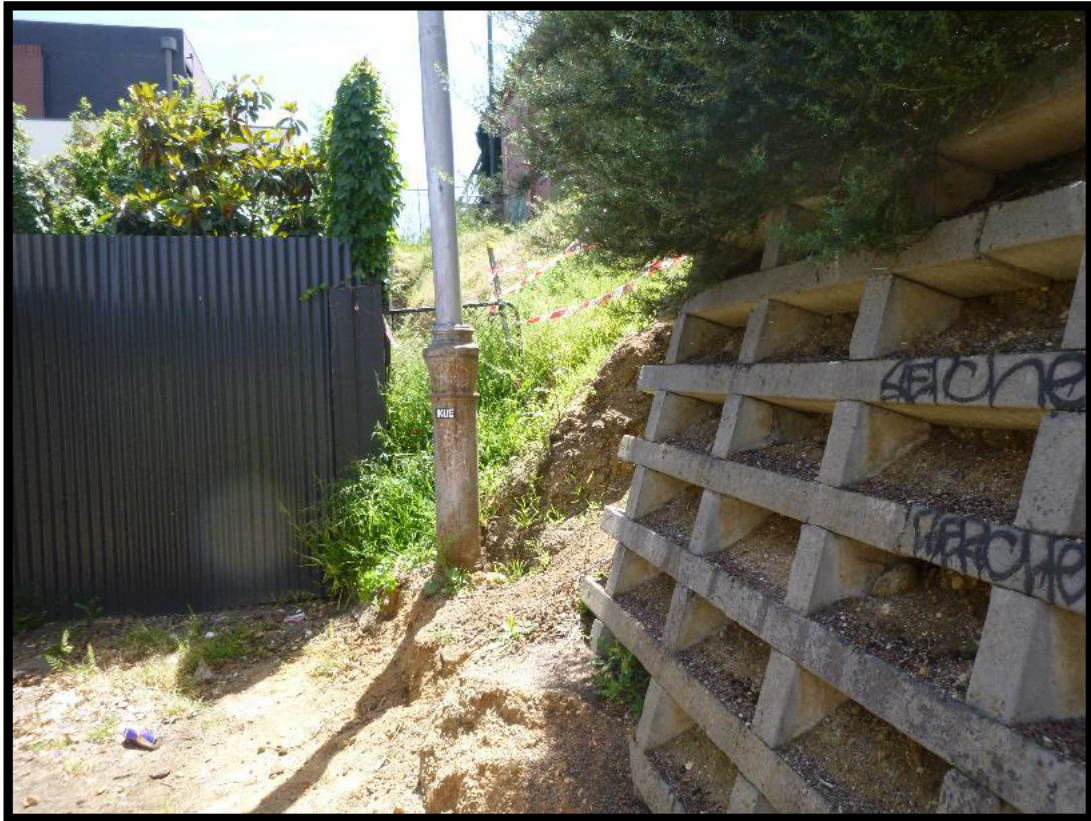
Photograph 3 – Photograph captured 19 November 2020. View of eastern end of subject land, looking west. Note spoil / loose material in laneway at the bottom of the batter. Slight erosion of material when compared to April 2019 (photograph 2).

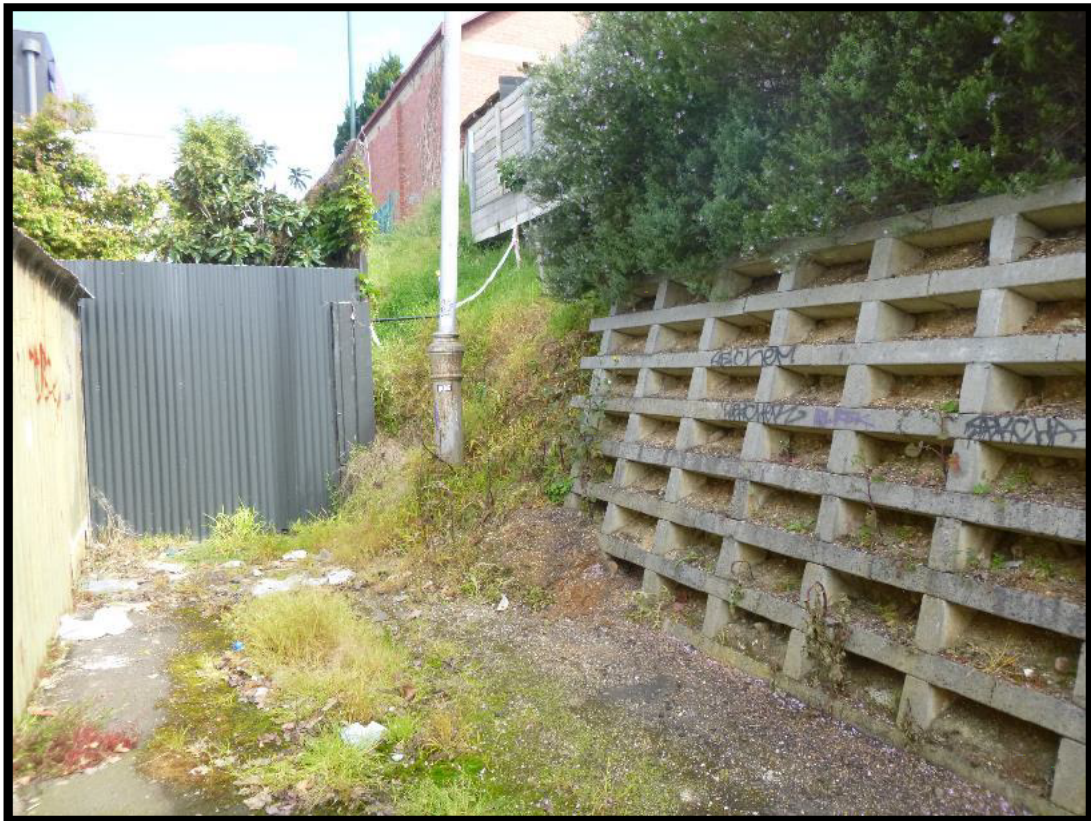
Photograph 4 – Photograph captured 13 October 2021. View of eastern end of subject land, looking north. Note spoil / loose material in laneway at the bottom of the batter, with vegetation growth over.

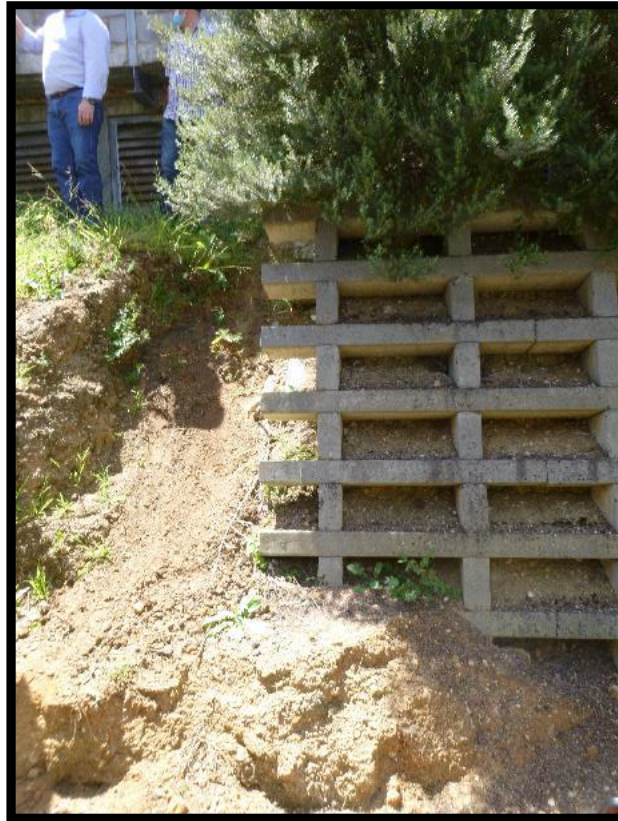
Photograph 5 – Photograph captured 19 November 2020. View of the eastern end of the subject land, looking north. Note localised erosion of land resulting in steep slope adjacent to crib wall.

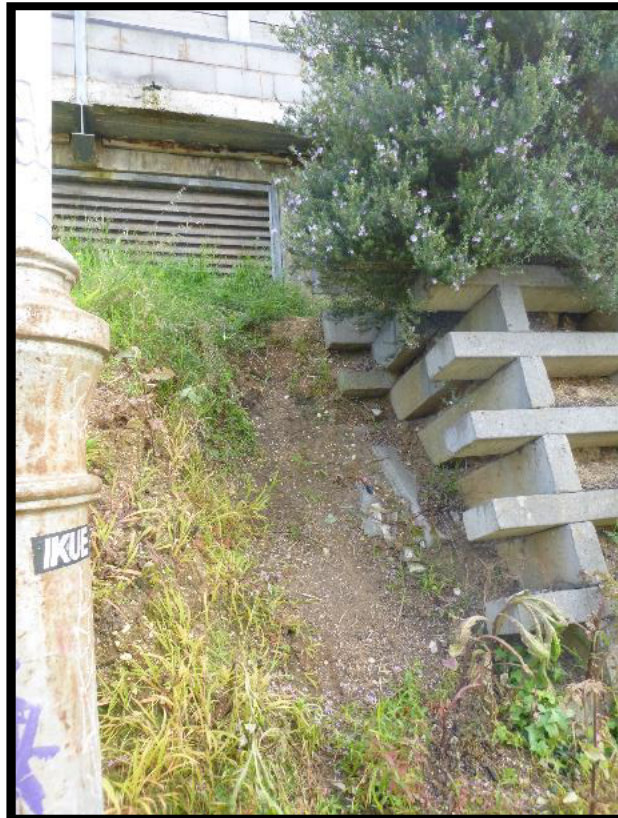
Photograph 6 – Photograph captured 14 October 2021. View of the eastern end of the subject land, looking north. Note localised erosion of land resulting in steep slope adjacent to crib wall.

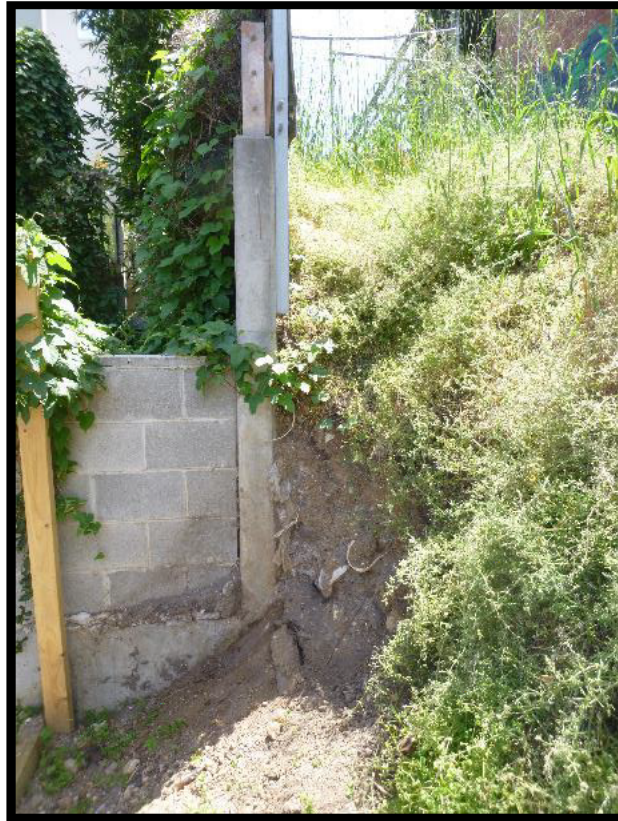
- Erosion of the ground has occurred between November 2020 and October 2021, to the western end of the subject land, adjacent to the concrete retaining wall at the north-west corner of 1 Campbell Grove, Northcote (retaining wall located at the north-east corner of 1A Campbell Grove, Northcote) [7 – 12].

Photograph 7 – Photograph captured 19 November 2020. View of the western end of the subject land, looking west, at the north-east corner of 1 Campbell Grove (north-east corner of 1A Campbell Grove). Note vertical face of earth adjacent to concrete retaining wall.

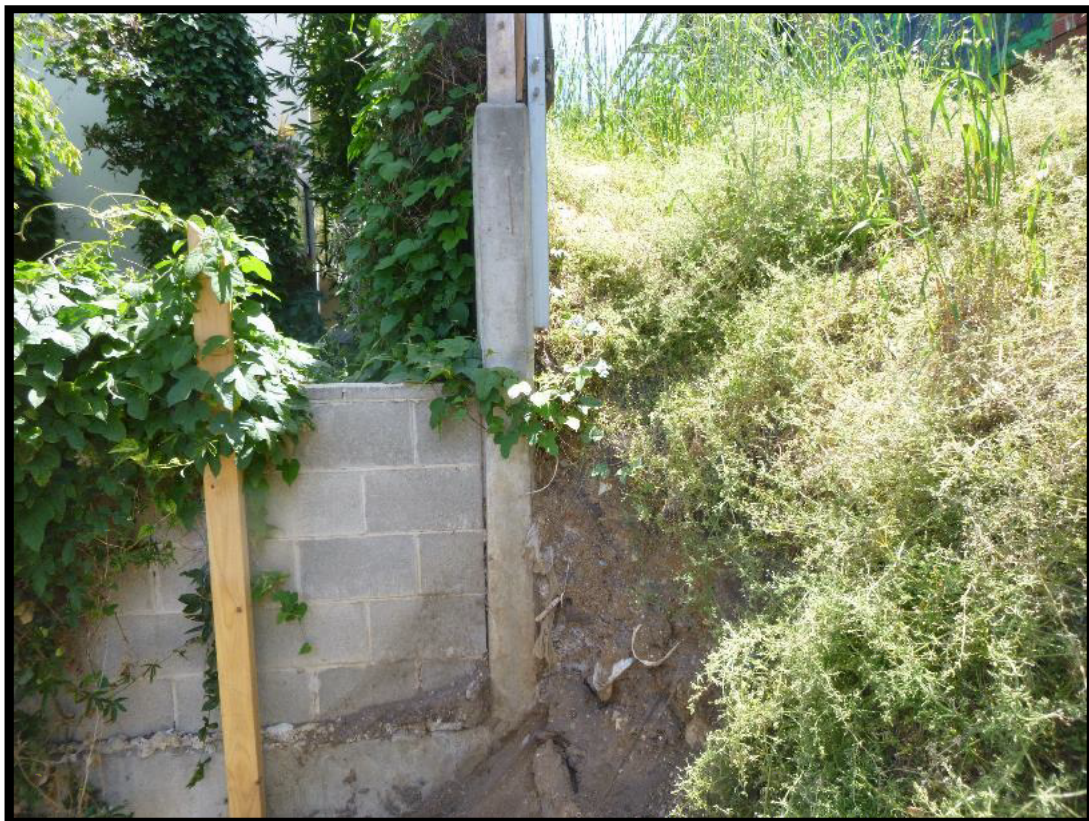
Photograph 8 – Photograph captured 19 November 2020. View of the western end of the subject land, looking west, at the north-east corner of 1 Campbell Grove (north-east corner of 1A Campbell Grove). Note vertical face of earth adjacent to concrete retaining wall.

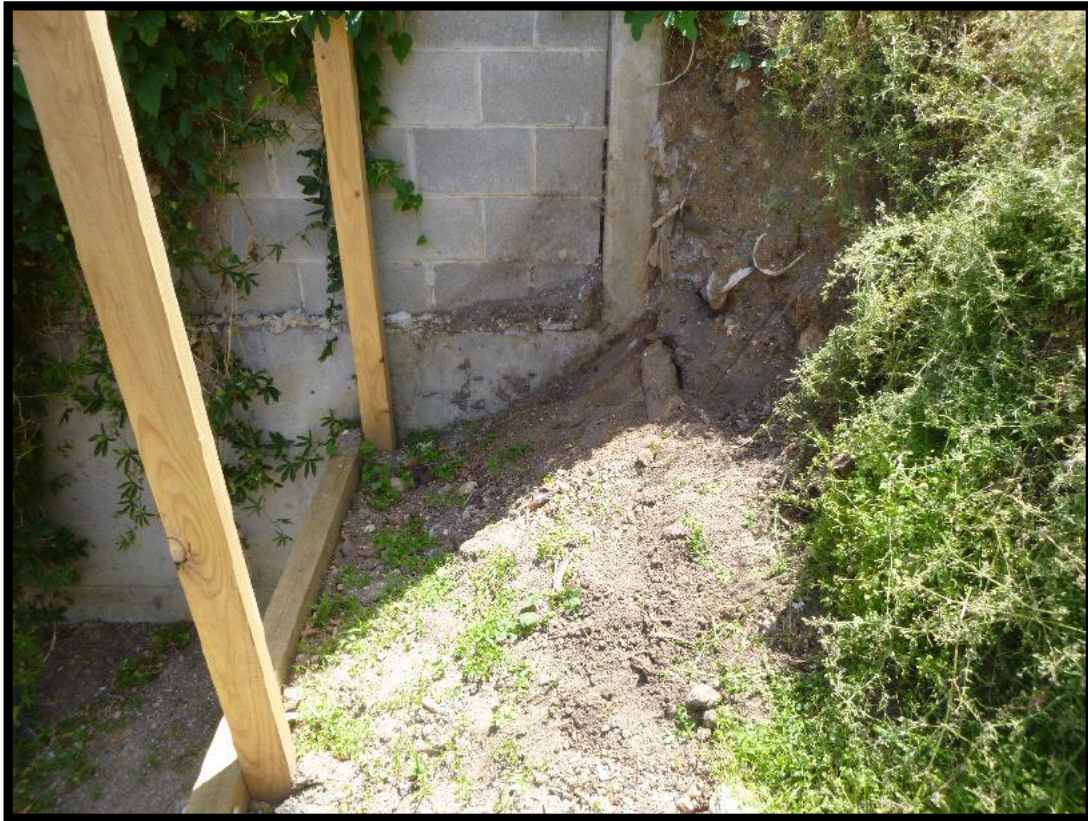
Photograph 9 – Photograph captured 19 November 2020. View of the western end of the subject land, looking west, at the north-east corner of 1 Campbell Grove (north-east corner of 1A Campbell Grove). Note vertical face of earth adjacent to concrete retaining wall.

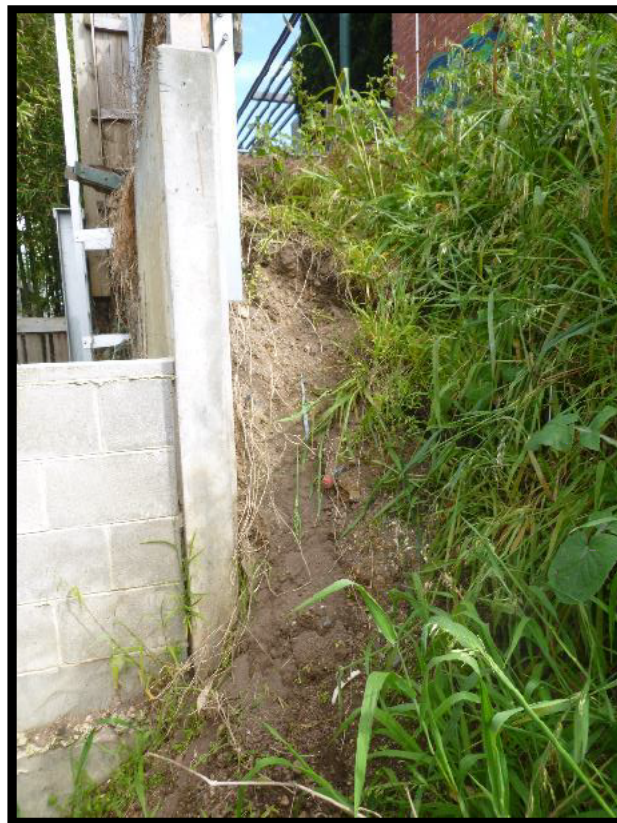
Photograph 10 – Photograph captured 13 October 2021. View of the western end of the subject land, looking west, at the north-east corner of 1 Campbell Grove (north-east corner of 1A Campbell Grove). Erosion of ground adjacent to retaining wall evident compared to November 2020 (photographs 7 – 9).

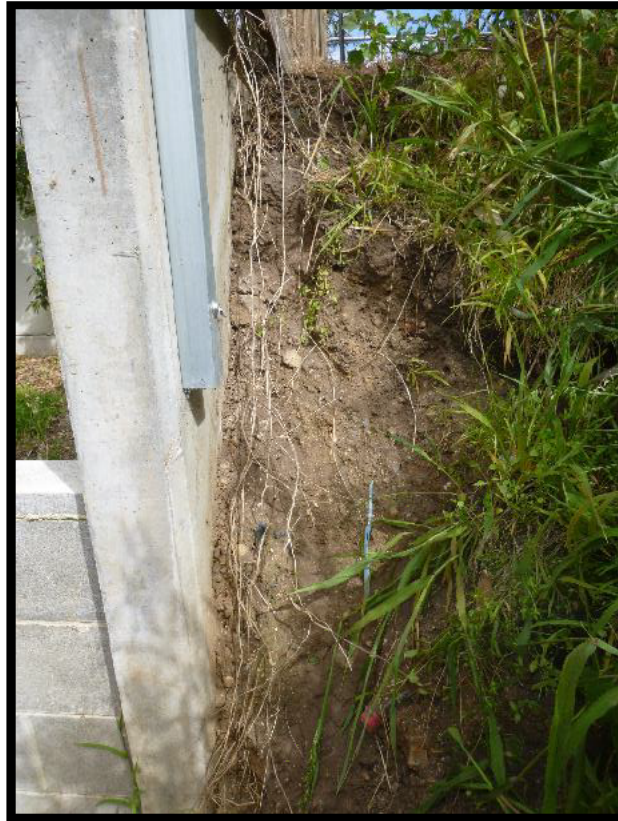
Photograph 11 – Photograph captured 13 October 2021. View of the western end of the subject land, looking west, at the north-east corner of 1 Campbell Grove (north-east corner of 1A Campbell Grove). Erosion of ground adjacent to retaining wall evident compared to November 2020 (photographs 7 – 9).

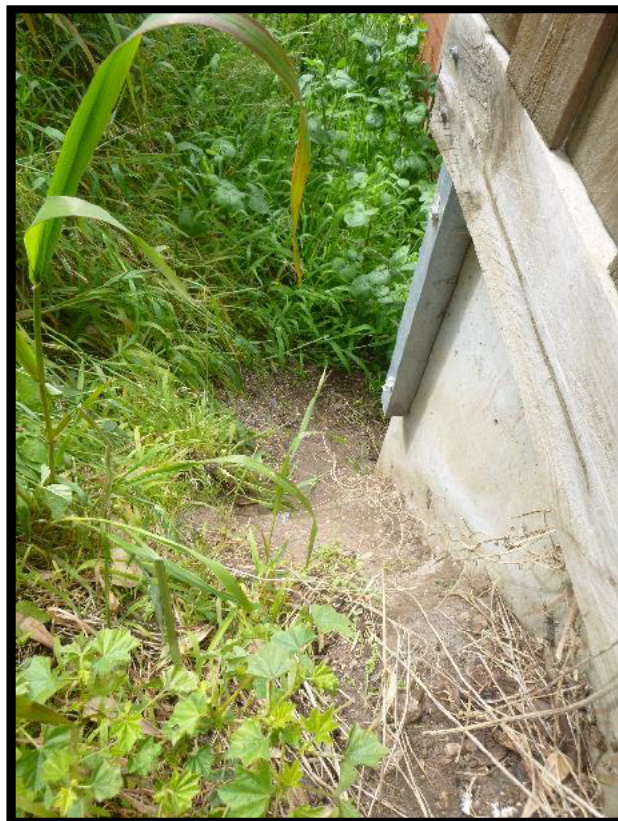
Photograph 12 – Photograph captured 13 October 2021. View of the western end of the subject land, looking east, at the north-east corner of 1 Campbell Grove (north-east corner of 1A Campbell Grove). Erosion of ground adjacent to retaining wall evident compared to November 2020 (photographs 7 – 9).

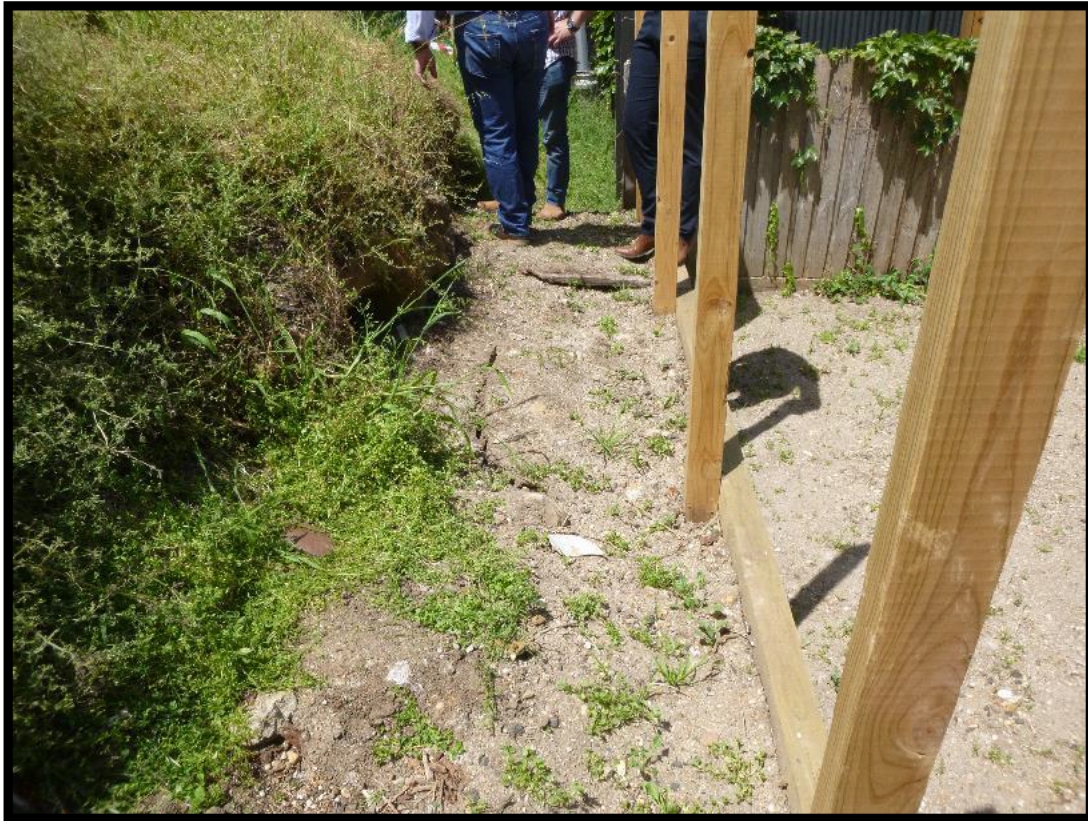
- Erosion / movement of the land along the southern side of the subject land (i.e. adjacent to the northern boundaries of 1 and 3 Campbell Grove, Northcote) does not appear to have occurred. Localised outcrops of rock are currently visible in this area, similar to November 2020, with no evidence of loose / displaced soil at the toe of the rock outcrops [13 – 17].

Photograph 13 – Photograph captured 19 November 2020. View along the southern side of the subject land looking east (i.e. long 1 Campbell Grove boundary).

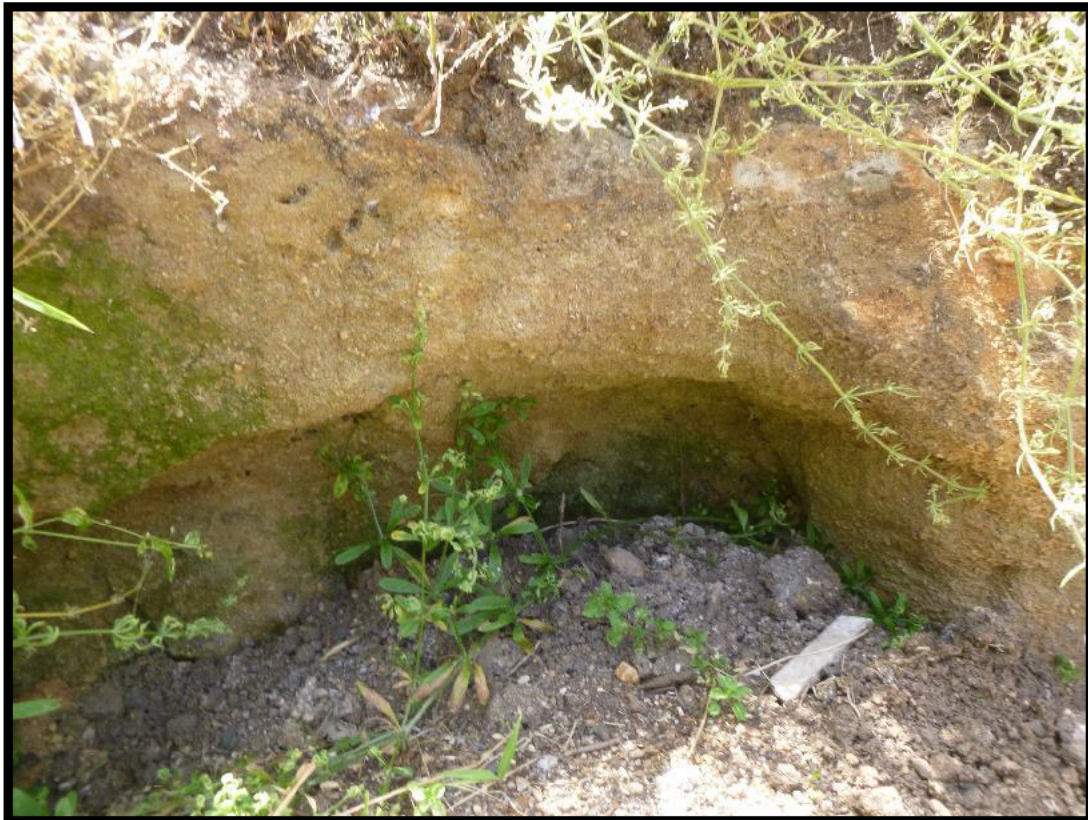
Photograph 14 – Photograph captured 19 November 2020. View of rock outcrop in area shown in photograph 13 above.

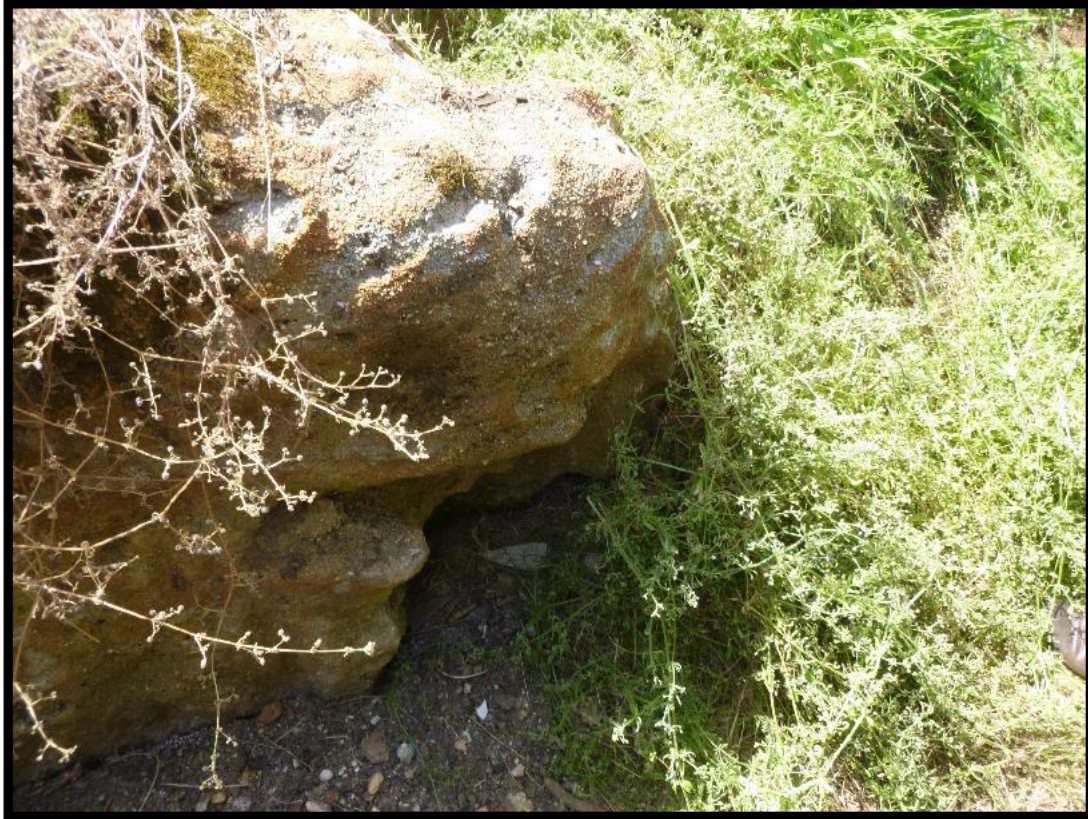
Photograph 15 – Photograph captured 19 November 2020. View of rock outcrop in area shown in photograph 13 above.

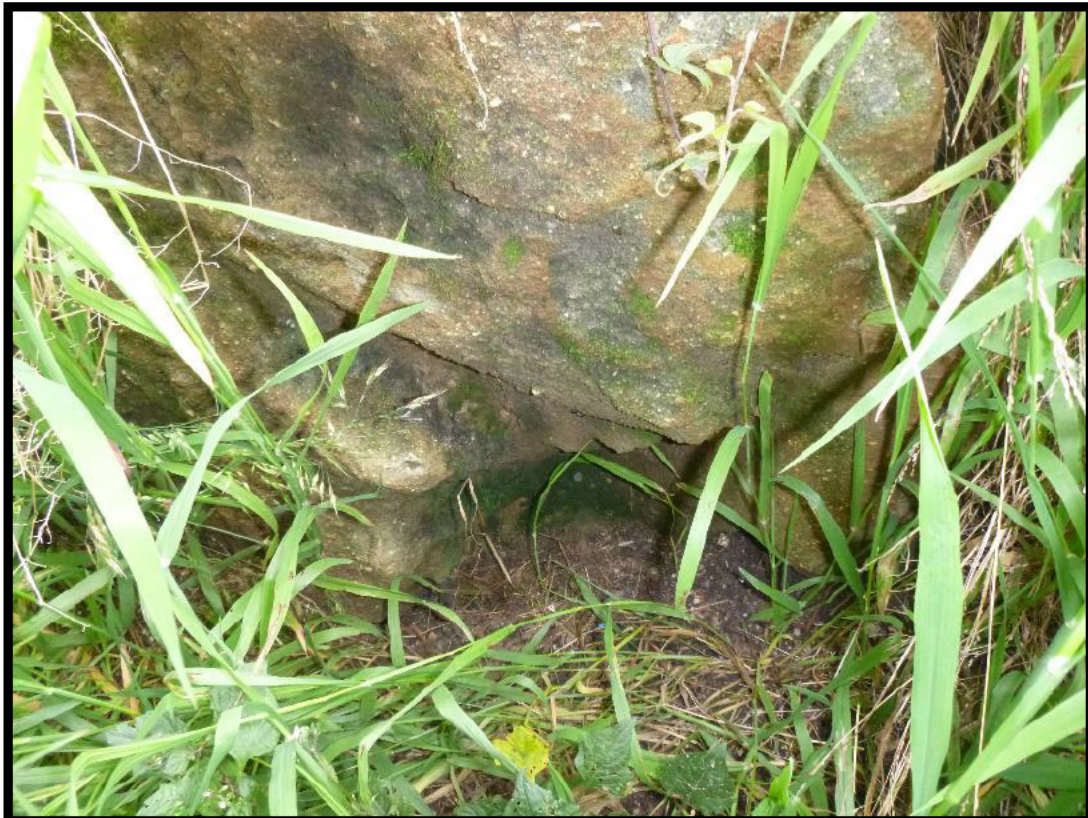
Photograph 16 – Photograph captured 13 October 2021. View of rock outcrop along the southern side of the subject land (i.e. long 1 Campbell Grove boundary). No evidence of loose / displaced soil at the toe of the rock outcrop.

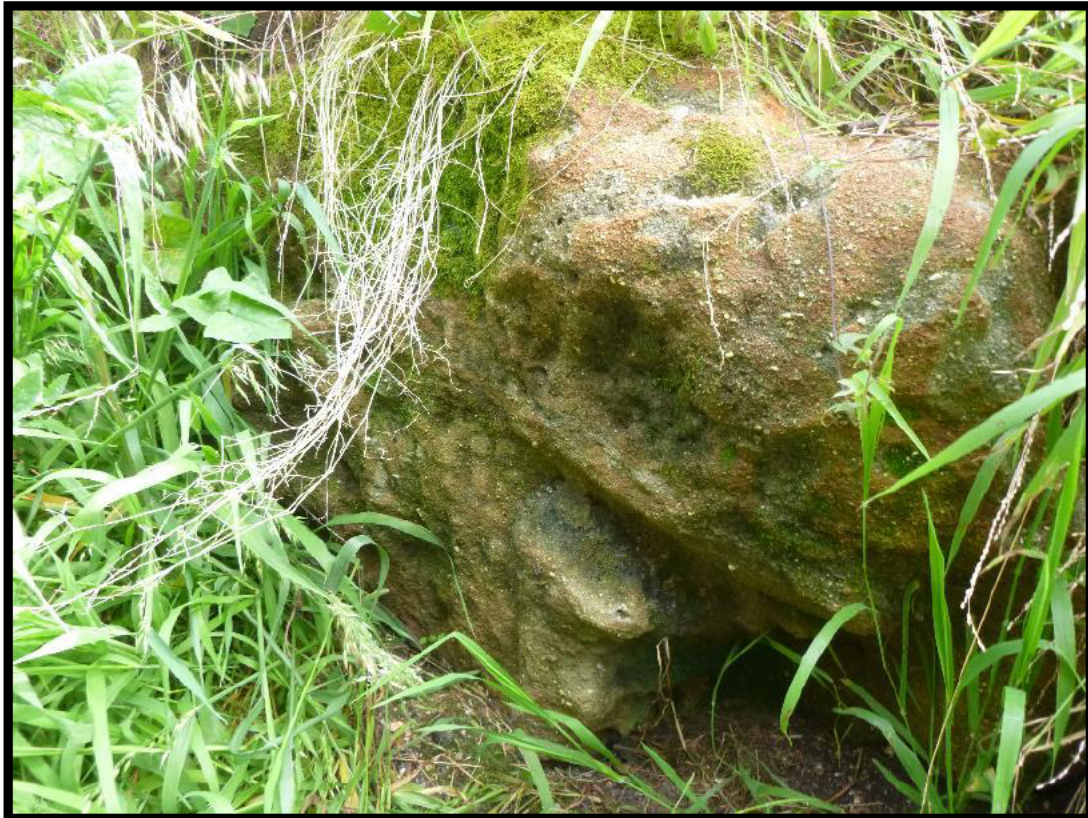
Photograph 17 – Photograph captured 13 October 2021. View of rock outcrop along the southern side of the subject land (i.e. long 1 Campbell Grove boundary). No evidence of loose / displaced soil at the toe of the rock outcrop.

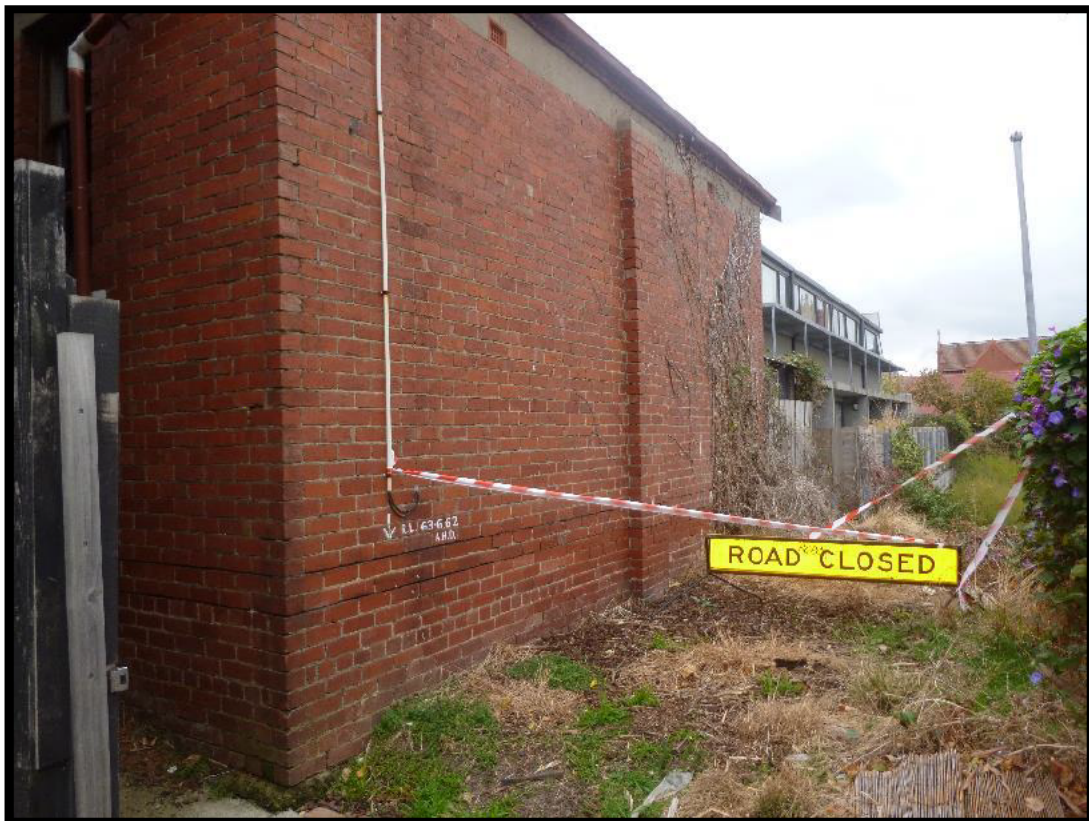
- No evidence of movement and / or damage to the brickwork wall along the south boundary of 42 James Street, at the top of the battered ground to the subject land [18 – 20].

Photograph 18 – Photograph captured 29 April 2019. No evidence of movement and / or damage to the brickwork wall along the south boundary of 42 James Street, at the top of the battered ground to the subject land.

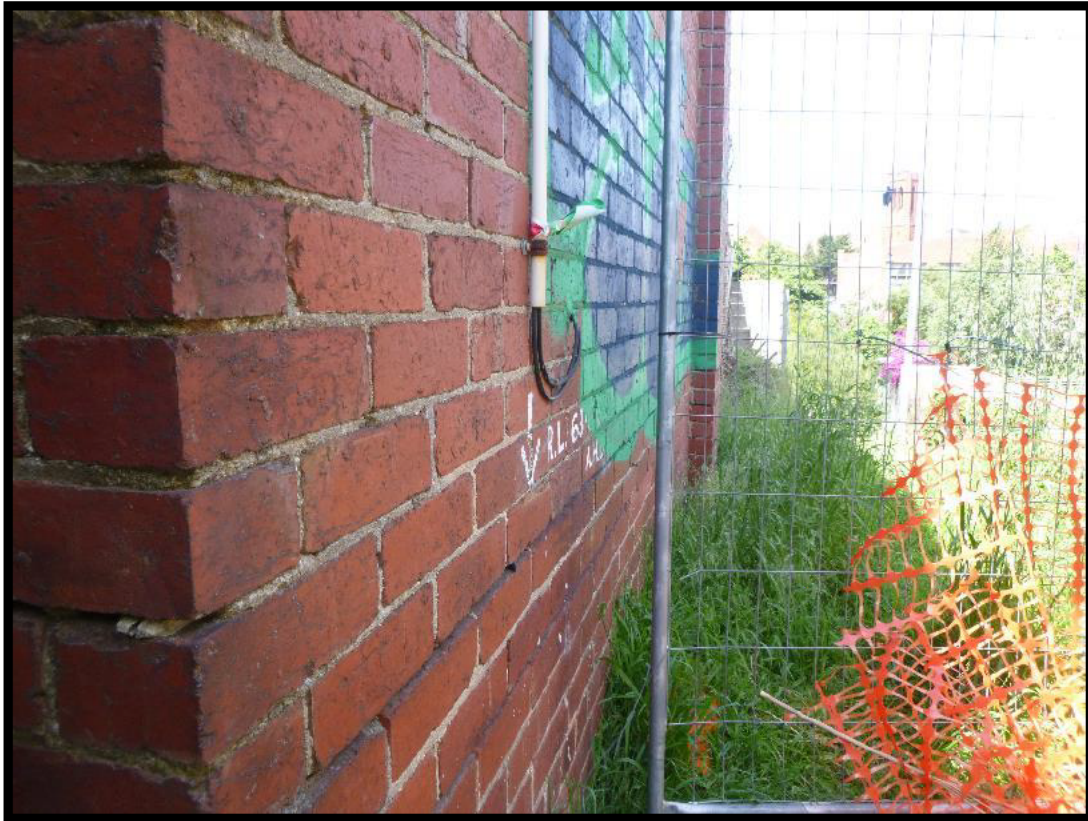
Photograph 19 – Photograph captured 19 November 2020. No evidence of movement and / or damage to the brickwork wall along the south boundary of 42 James Street, at the top of the battered ground to the subject land.

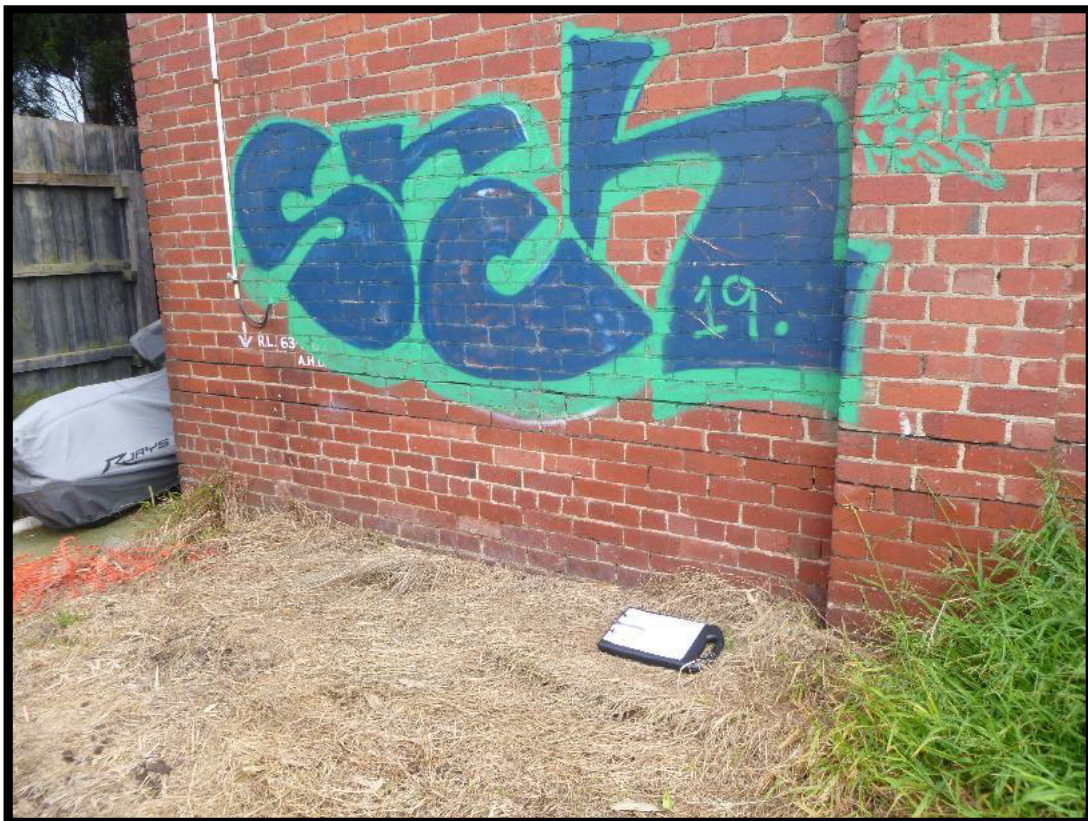
Photograph 20 – Photograph captured 13 October 2021. No evidence of movement and / or damage to the brickwork wall along the south boundary of 42 James Street, at the top of the battered ground to the subject land.

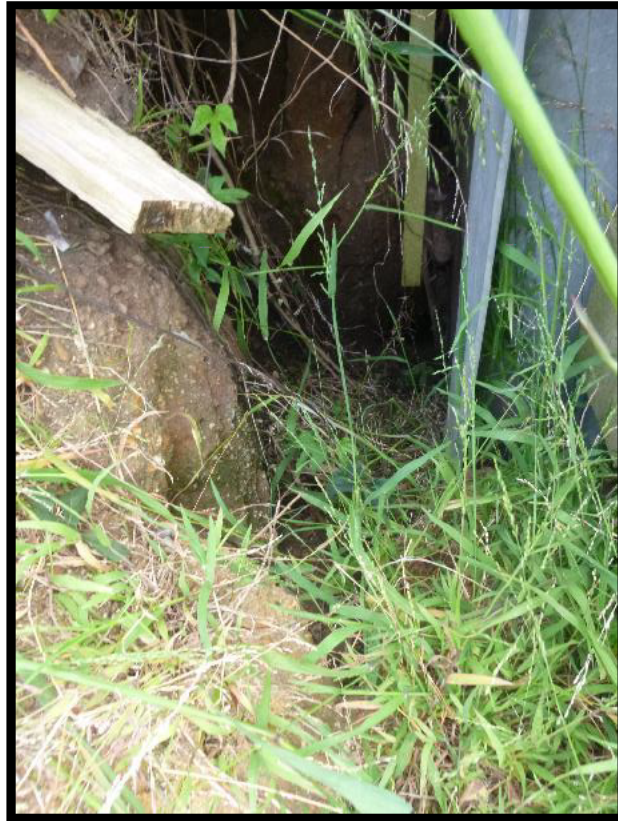
Along with the above, during the recent inspection, a localised void was evident beneath the south-east corner of the property boundary to 42 James Street, with the void appearing to extend beneath the south-west corner of property to the east of 42 James Street [21]. FMG notes that this void was evident during the inspection in November 2020, however it is unclear as to whether this void has increased in size. Based on the location of the void, stormwater run-off can enter the void and enter beneath the property at 42 James Street and the neighbouring site to the east.

Photograph 21 – Photograph captured 13 October 2021. View of localised void beneath the south-east corner of the property boundary to 42 James Street, with the void appearing to extend beneath the south-west corner of property to the east of 42 James Street.
