# Preliminary Geotechnical Investigation Report

<b>Job Number</b>	281686
<b>Client</b>	City of Darebin
<b>Site</b>	42 James Street, NORTHCOTE, VIC 3070
<b>Date</b>	27/07/2022
<b>Revision</b>	0

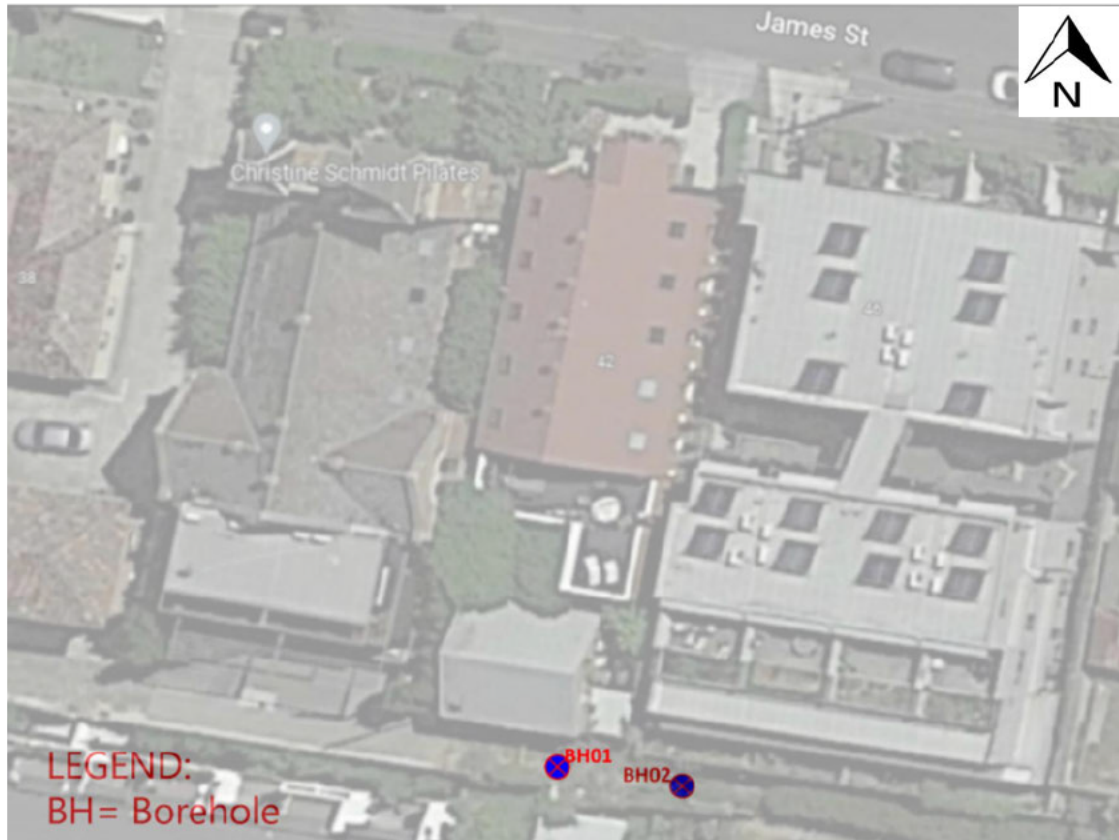
Figure 1: Site location

FMG Engineering (FMG) has been commissioned to undertake a geotechnical investigation at 42 James Street, NORTHCOTE, VIC 3070. The approximate site extents are shown below in Figure 1.

Borehole/test locations are shown on the site plan included in Figure 1. A summary of achieved depths is shown in Table 1.
